From: Willman, Jerry <Jerry.Willman@Illinois.gov>
Sent: Friday, July 10, 2020 11:57 AM
To: Ribordy, Michael
Cc: Mendoza, Ramon; Kondreck, Robert
Subject: RE: Nelson Knitting - 909 S Main St, Rockford, IL

Cc: Cragan, Keary <cragan.keary@epa.gov>; Karl Franzen <Karl.Franzen@rockfordil.gov>; Nelson Sjostrom <Nelson.Sjostrom@rockfordil.gov>; Mike Rotolo <Mike.Rotolo@rockfordil.gov>; Brian Bracken <Brian.Bracken@rockfordil.gov>; Chad Baker <Chad.Baker@rockfordil.gov>
Subject: Nelson Knitting - 909 S Main St, Rockford, IL

Subject: [External] FW: Nelson Knitting Concerns

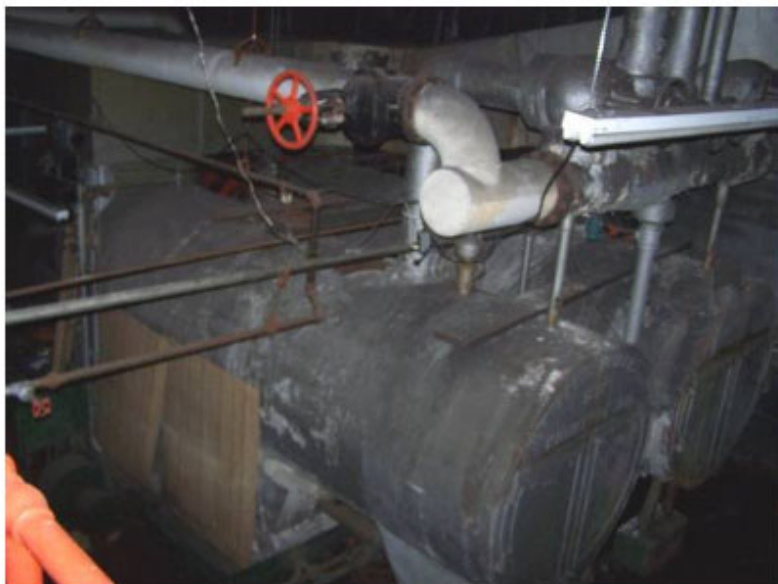
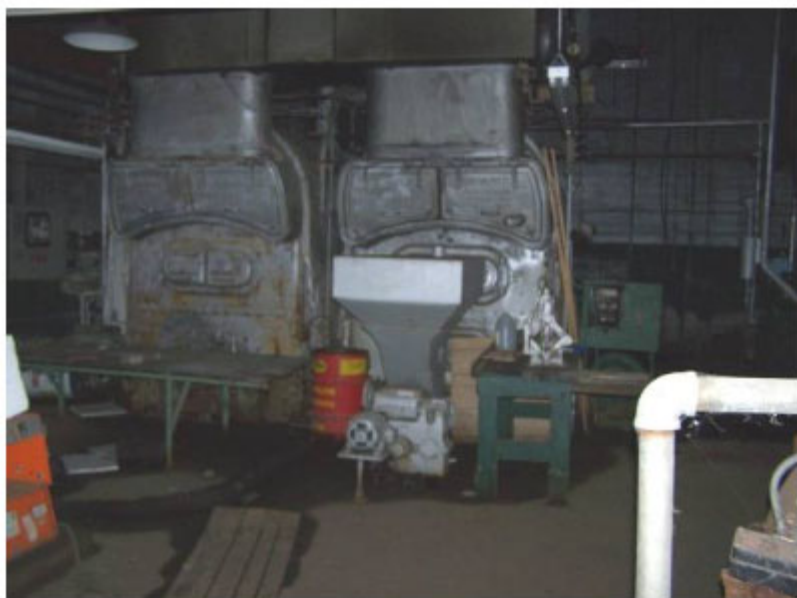
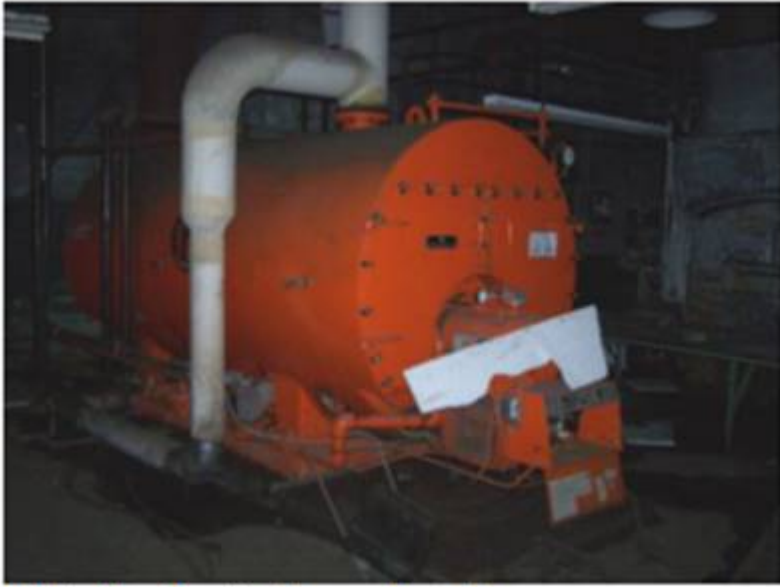
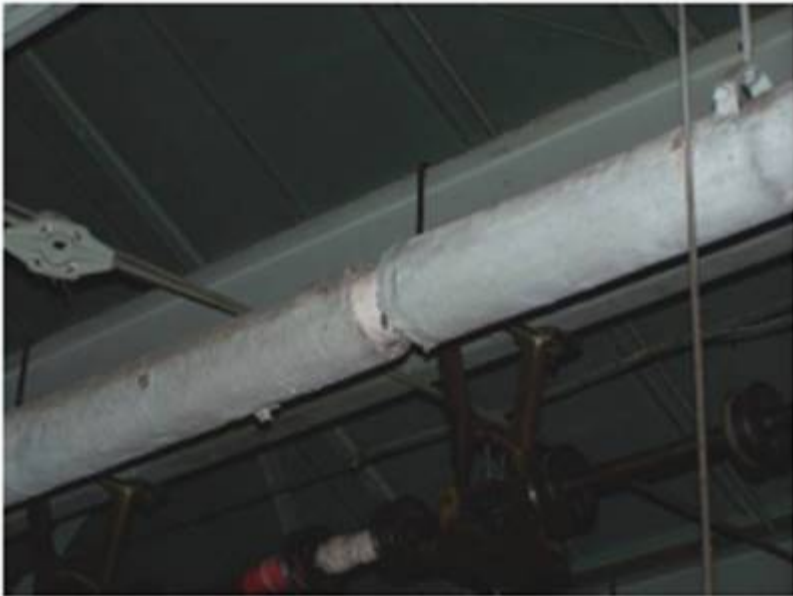
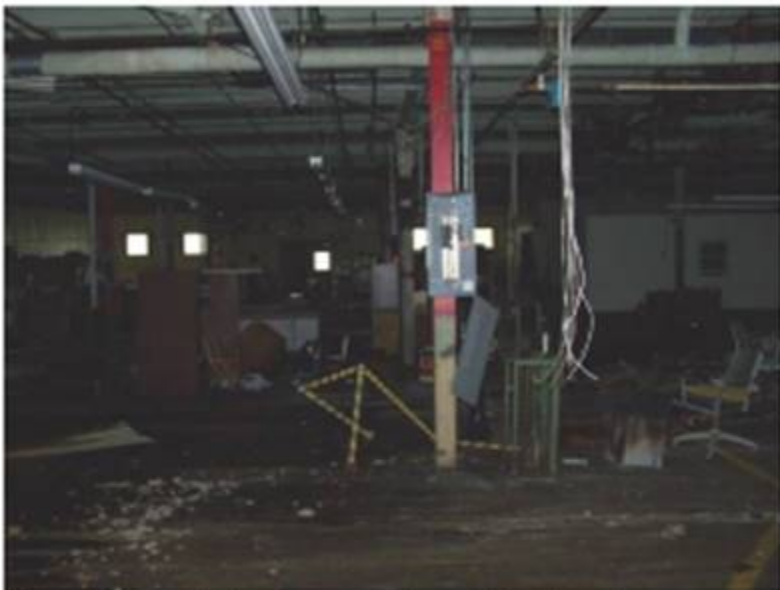
Fast forward 13 years to June 25, 2020. I was driving past the building and observed that its southern entrance had been compromised. Knowing the City has forthcoming Building and Property Maintenance Code cases on the property, I wanted to observe the interior conditions and screen for hazards before our building inspectors enter, as I am 40-Hr HAZWOPPER certified. As you can see from the pictures below, I observed that the boiler room had been completely gutted and all boilers and steam piping removed. The first 5 pictures below are ones that I took in 2008 documenting the condition of the boiler room and other areas containing suspect asbestos materials. The 1992 RCA report stated that all 3 boilers had a jacket covering but I only recall the 2 large Kewanee Boilers (silver) having it. The following 3 pictures are ones I took on the 25th of the boiler room in its current state. Please note the suspected asbestos materials on the floor and around the former base of the salvaged boilers. When I returned to the office, I verified that there was no Asbestos 10 Day Notification on file for the property, which heightened our concern. Additionally, I spoke with the gentleman that completed the salvage work around 2008 and he stated that he *"hired someone to come in and remove all the scrap metal and boilers back before scrap prices dropped"* circa September 2008. As you can see, we not only have concern about what was left in the boiler room and throughout the building as a result of the salvage operation but also where the materials identified in the 1992 and 2008 reports ultimately ended up. I have the full 2008 Phase I report that I can provide. Another major concern we have is the roofing systems, which I observed failing in multiple locations. If the roof systems still consists of *"sheet rock and poured asbestos,"* this adds another potential exposure risk to the surrounding public.

On Friday, June 26, 2020, myself and members from our building department revisited the property with property PPE and officially condemned it. We also placarded the entrances with a red "X" that notifies our first responders that hazardous conditions exist inside. With the proper PPE, were able to take a more detailed looks at the entire building. We were astonished at the negligence we encountered upon our detailed walk through. **You can access photos of what we witnessed at the following link:** <https://photos.app.goo.gl/SM3vrNzrLCibzcUj7>. As you can see, we were able to locate the formerly intact asbestos in the building, as it has been removed from all the salvaged steel and boilers and piled is several locations. Please note the black garbage bags filled with Aircel and jacket insulation hidden in the corner of the boiler room. Also, please note the massive pile on lower level and the fiber drums filled with pipe wrap. These same fiber drums are visible in my 2008 pictures as containing fluorescent lamps. In one area we located a pile of asbestos immediately next to a make-shift bead for what we presume was a homeless individual. The suspected asbestos poured roofing material is collapsing into the interior throughout the upper level of the structure well. I spoke with the new curator of Tinker Swiss Cottage today that stated the owner approached them last fall and tried to sell the property. After they declined his offer, , he made a comment that he would probably just walk away from it. I checked for delinquent property taxes after hearing this and the 2017, 2018, and first installment of the 2019 taxes have not been paid. After 3 years of delinquent taxes, our county tax trustee program will typically take back the property and auction it off. I have already reached out to the Trustee Program and recommend that they do not acquire the property and that it remains in the current owners name. Our concerns are that the roof and damaged asbestos containing materials are potentially being released to the surrounding area and that if the roof were to collapse or building were to catch fire, the exposure risk with substantially increase. We also fear that the owner does not have the kind of assets to perform this level of cleanup or demolition. We stepped in and secured the building on the 26th to ensure nobody would re-enter it. I will work with our local fire department to see if we can get some drone shots of the roof to better document the exposure risk. As we move forward with our Circuit Court case for the building code violations, we would more than welcome to with USEPA in partnership as there will be some degree of overlap with potential cleanup requirements and the building repairs or demolition that may be required. The building owner contact information is as follows. I will work on obtaining a contact number for the individual.

We will be mobilizing back to the property this morning to officially condemn and secure the building and placard it with a red "X" that notifies our first responders that hazardous conditions exist inside. I will also be able to get a better look

at the materials on the floor of the boiler room as I will have the appropriate PPE to enter the room. We would very much appreciate Illinois EPA's assistance in looking into the suspected NESHAP violations and potential threat to human health and the surrounding environment. We also would like to work in partnerships as we move forward with our forthcoming circuit court case on the building code violations, as there will be some degree of overlap with potential cleanup requirements and the building repairs or demolition that may be needed. We can also provide you with the contact information for the building owner and the contractor that reclaimed the building materials back in 2008. If you need to reach me today, please call my cell at Not responsive - Ex. 6. Thank you.

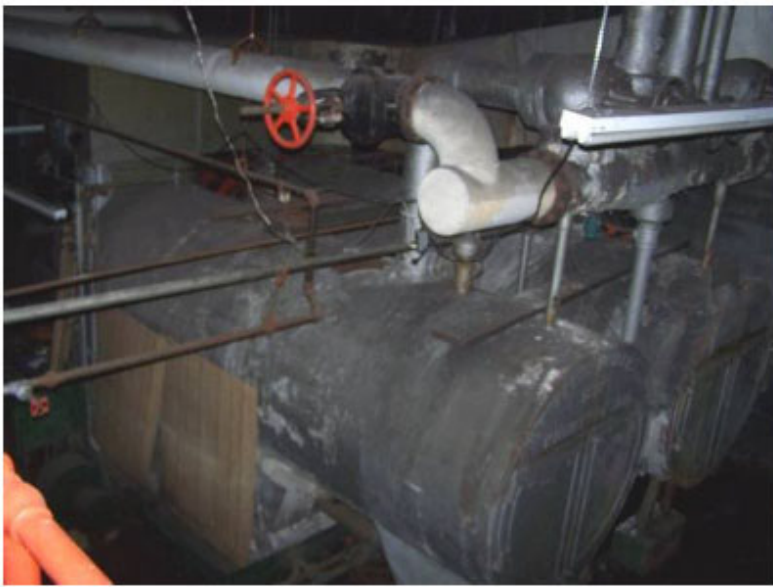
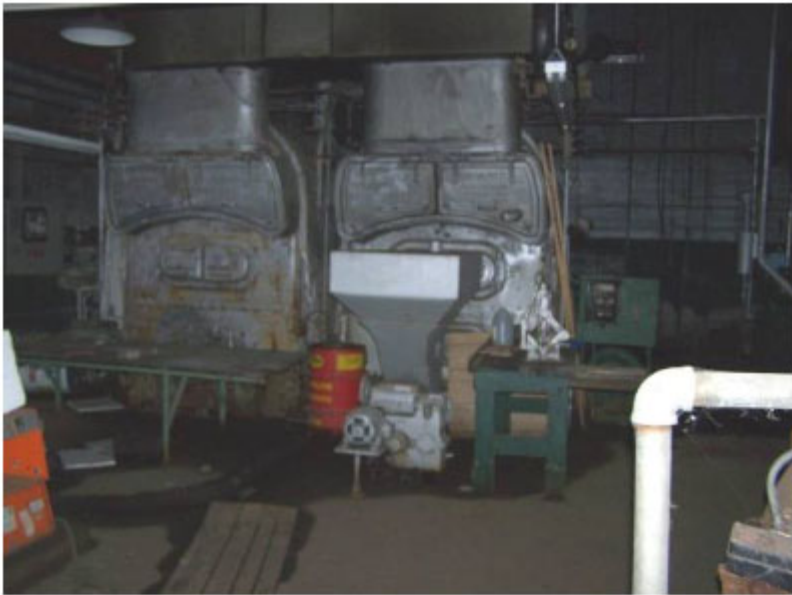
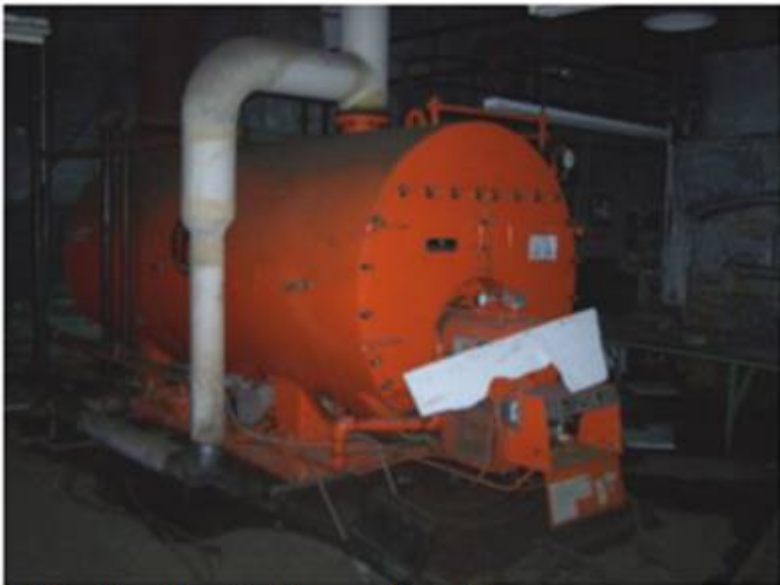
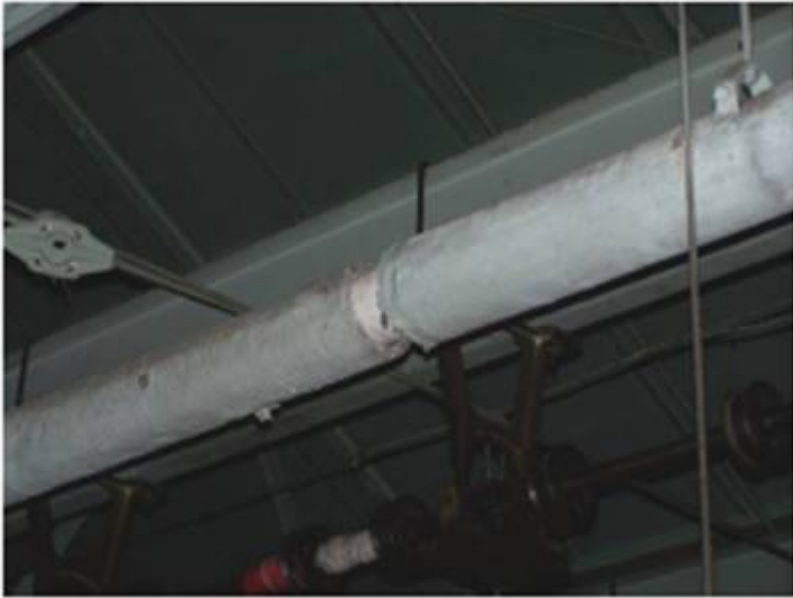
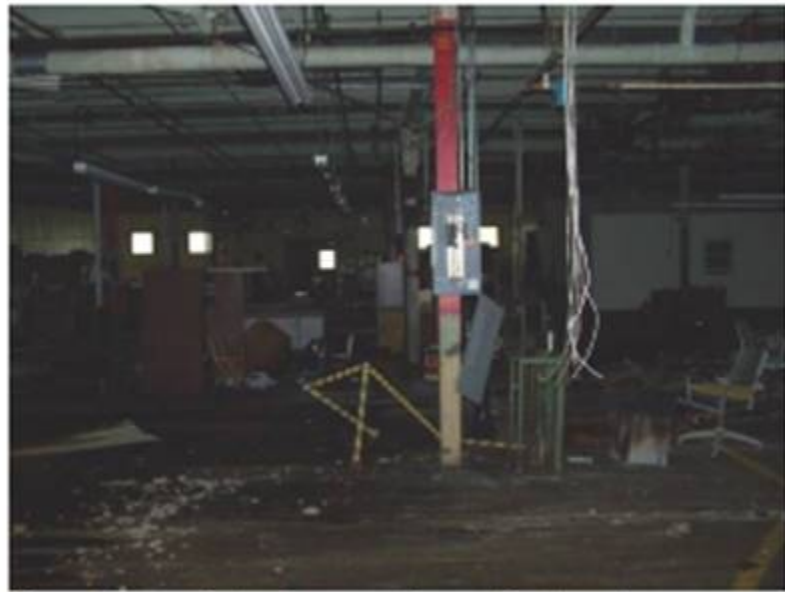
Fast forward 13 years to yesterday, I was driving past the building and observed that its southern entrance had been compromised. Knowing the City has forthcoming Building and Property Maintenance Code cases on the property, I wanted to observe the interior conditions and screen for hazards before our inspectors enter the building, as I am 40-Hr HAZWOPPER certified. As you can see from the pictures below, the boiler room has been completely gutted and all boilers and steam piping removed. The first 5 pictures below are ones that I took in 2007 documenting the condition of the boiler room and other areas containing suspect asbestos materials. The 1992 RCA report stated that all 3 boilers had a jacket covering but I only recall the 2 large Kewanee Boilers (silver) having it. The following 3 pictures are ones I took yesterday of the boiler room in its current conditions. Please note the suspected asbestos materials on the floor and around the former base of the salvaged boilers. When I returned to the office, I verified that there was no Asbestos 10 Day Notification on file for the property, which elevated our concern. Additionally, I spoke with the gentleman that completed the salvage work around 2008 and he stated that he *"hired someone to come in and remove all the scrap metal and boilers back before scrap prices dropped"* circa 2008. As you can see, we not only have concern about what was left in the boiler room and throughout the building as a result of the salvage operation but also where the materials identified in the 1992 and 2007 reports ultimately ended up. I can send you the 2007 Phase I report and will also pull the full set of original pictures that didn't make it into the report to see if there is anything else relevant. Another item we now have concern with is the roofing systems, which I observed failing in multiple locations. If the roof systems still consists of *"sheet rock and poured asbestos,"* this adds another potential exposure risk to the surrounding public.

We will be mobilizing back to the property this morning to officially condemn and secure the building and placard it with a red "X" that notifies our first responders that hazardous conditions exist inside. I will also be able to get a better look at the materials on the floor of the boiler room as I will have the appropriate PPE to enter the room. We would very much appreciate Illinois EPA's assistance in looking into the suspected NESHAP violations and potential threat to human health and the surrounding environment. We also would like to work in partnerships as we move forward with our forthcoming circuit court case on the building code violations, as there will be some degree of overlap with potential cleanup requirements and the building repairs or demolition that may be needed. We can also provide you with the contact information for the building owner and the contractor that reclaimed the building materials back in 2008. If you need to reach me today, please call my cell at [redacted] Thank you.
